# Manhole Inspection Summary

Manhole # S09SS\_008MH

Insp Date: **7/20/07 8:12 AM**

**Location** Address: **3400 POWHATAN AVE**

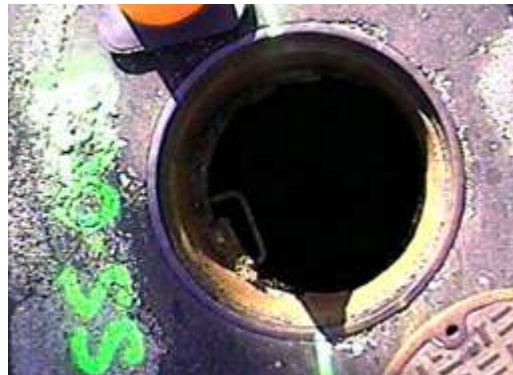
Defect 2

Offset: **2** (in.)

OFFSET FRAME

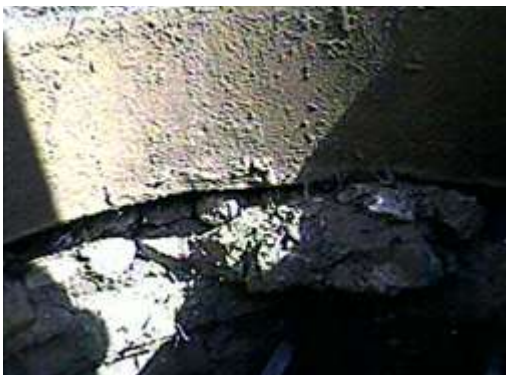
Defect 1

Condition: ☐ Sound ☐ Cracked ☐ Root Intrusion ☒ **Loose Brick** ☒ **Deteriorated**

LOOSE BRICKS AND DETERIORATED  
ADJ.

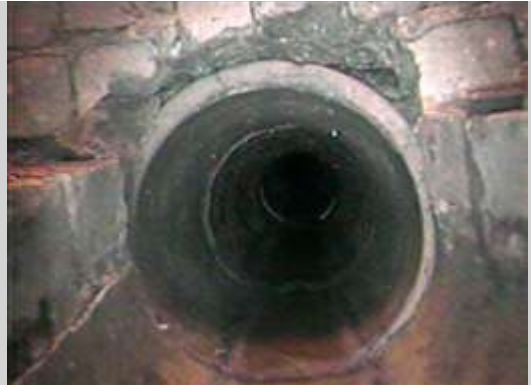
12 O'Clock Outflow

8 in. Circular Gravity Sewer  
Pipe Out @ 12 O'Clock

Infiltration: **None** Pipe Seal Cond: **Cracked**

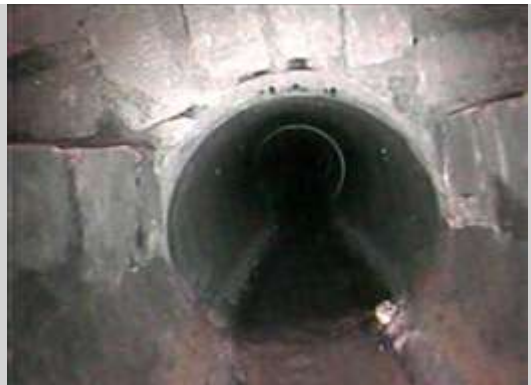
6 O'Clock Inflow

8 in. Circular Gravity Sewer  
Pipe In @ 6 O'Clock
